OSSIX[®] Plus

Correction of Vertical Fracture
and Subsequent Infection

Dr. Matthew J Fien, DDS, FL, USA

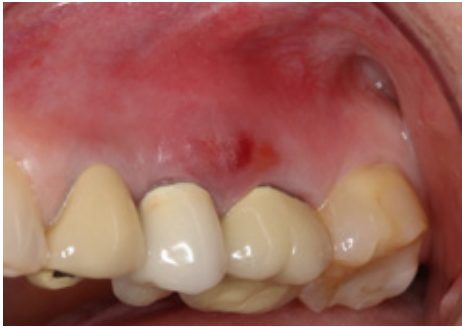
Pre-op Buccal view

46 year old female with a non-contributory medical history presented for evaluation and treatment of swelling in her upper left quadrant. Intra oral exam revealed moderate swelling and a buccal fistula 3 mm from gingival margin of tooth 13. The radiograph revealed severe bone loss as a result of fracture and subsequent infection of tooth 13. Following extraction and full thickness flap reflection, all granulomatous tissue was meticulously debrided from the defect. The defect was grafted with a freeze dried bone allograft and an OSSIX® Plus membrane was adapted to the buccal occlusal palatal line angle and secured with a periosteal biting stabilization suture.

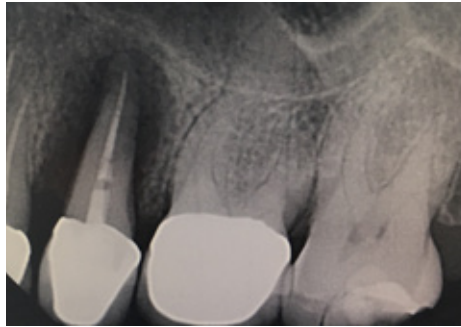
Pre-op X-ray

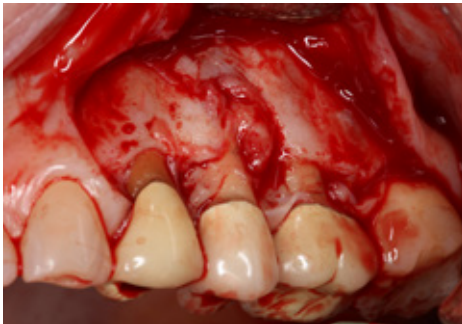
Full thickness flap reflection

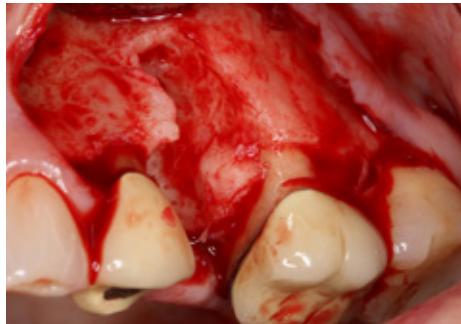
Extraction and degranulation

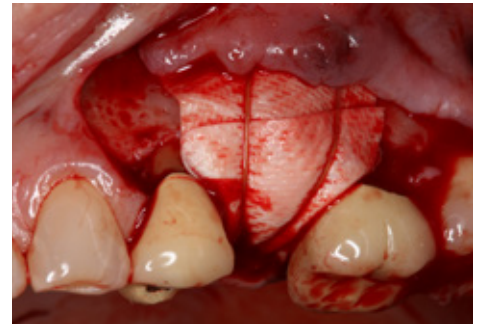
Membrane stabilization with resorbable suture

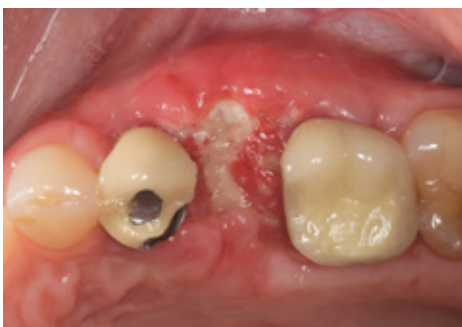
Occlusal view of healing at 2 weeks post-op reveals soft tissue dehiscence at incision line but no signs of infection

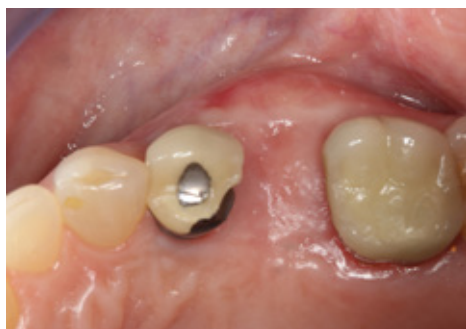
Full recovery after 4 months. Note significant increase in contours of ridge in the area of previous infection

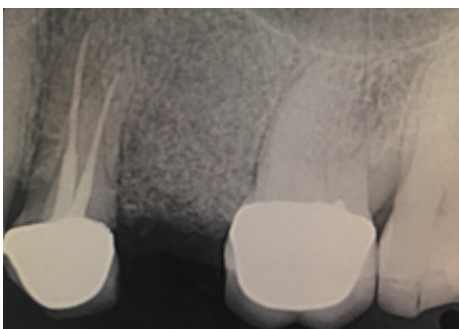
Radiograph at 4 months post-op reveals complete defect fill and good incorporation of bone graft. Note the maintenance of vertical height of alveolar ridge despite the presence of severe dehiscence defect at the time of extraction

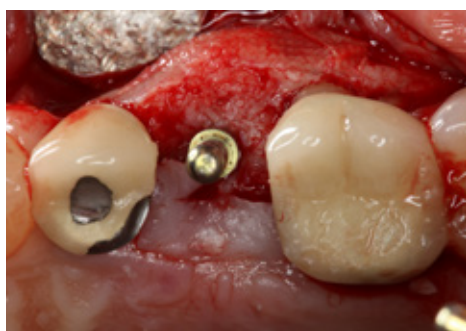
Occlusal view at the time of implant placement following initial osteotomy preparation and placement of a guide pin. Note significant increase in ridge width beyond the confines of the alveolar housing
